CAUSE NO. D150358C

**PLAINTIFFS' ORIGINAL PETITION**

Helen Chandler Residence  
San Angelo, Texas  
Haag File: 0614000099-249/601

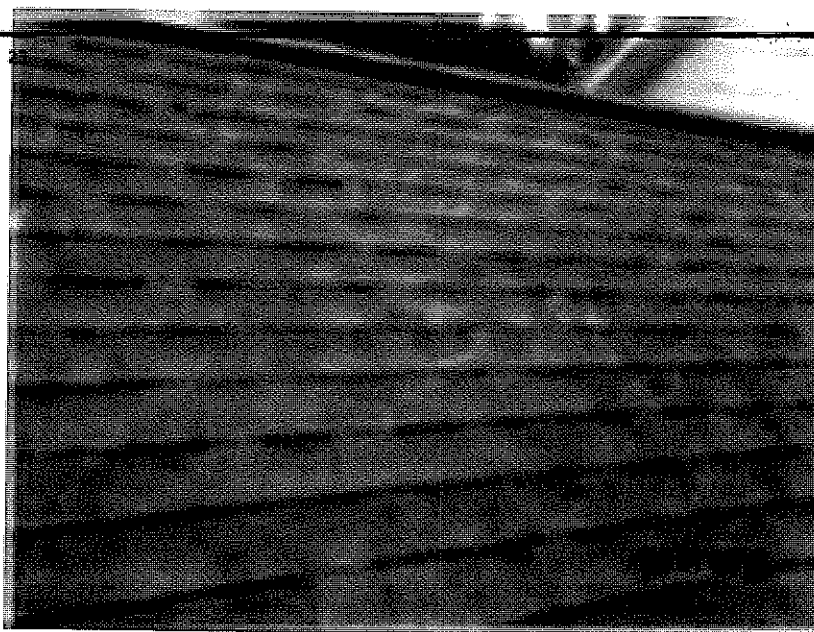
South Slope - Many of the hail marks subsequently identified as blistering or normal wear,

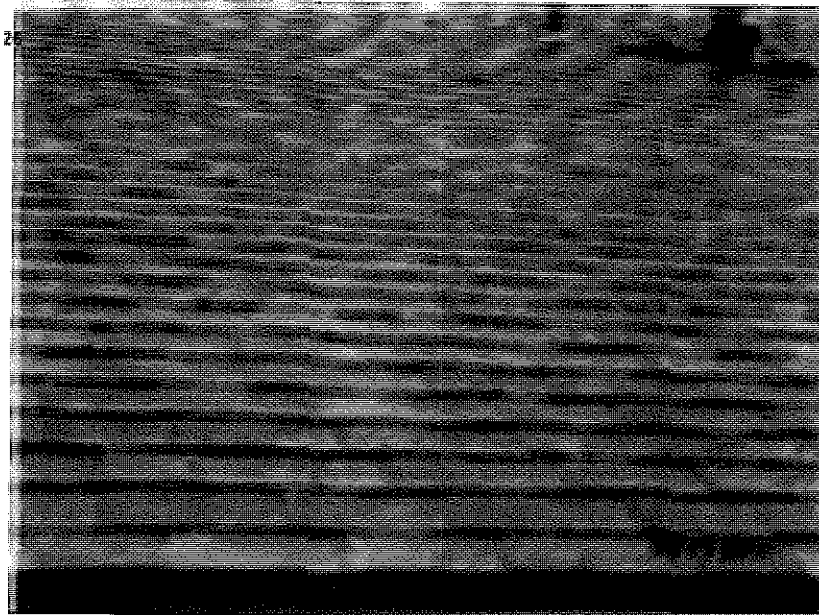
North Slope - No hail damage identified

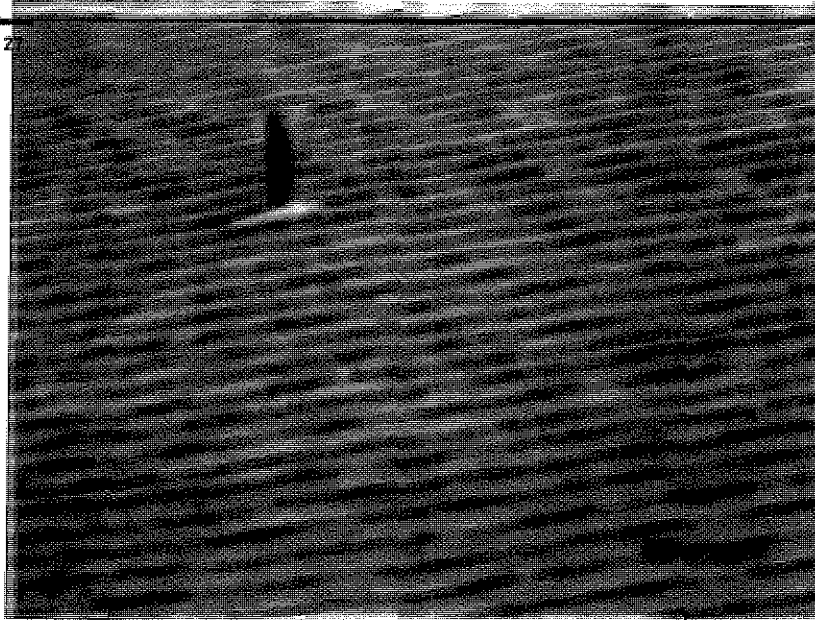
Soft Metals - Hall damage to vent

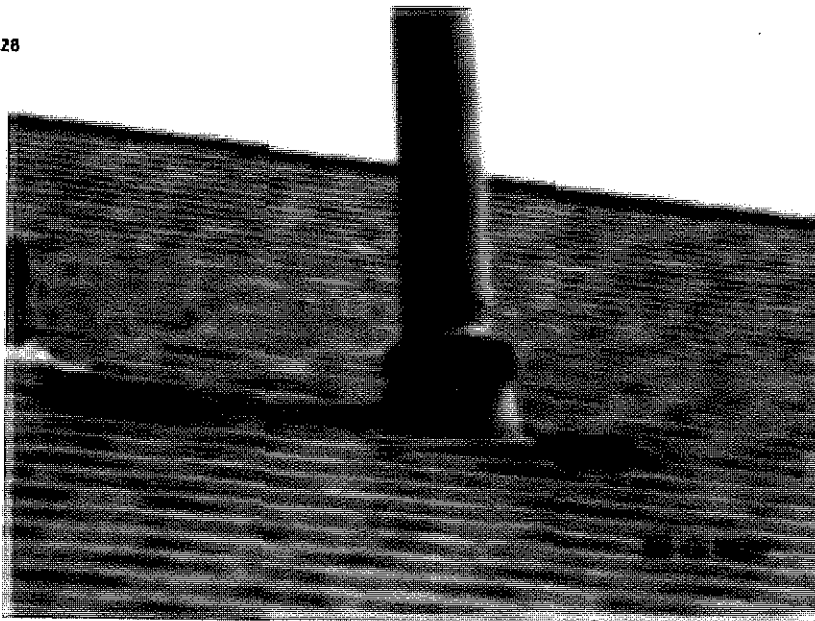
Soft Metals - Wind damage to vent

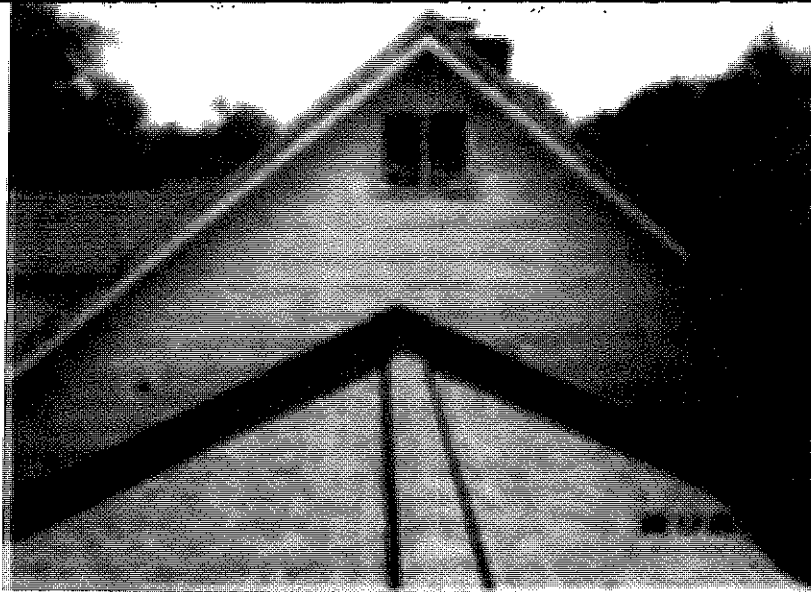
West Elevation - Damage due to maintenance issues, not storm related.

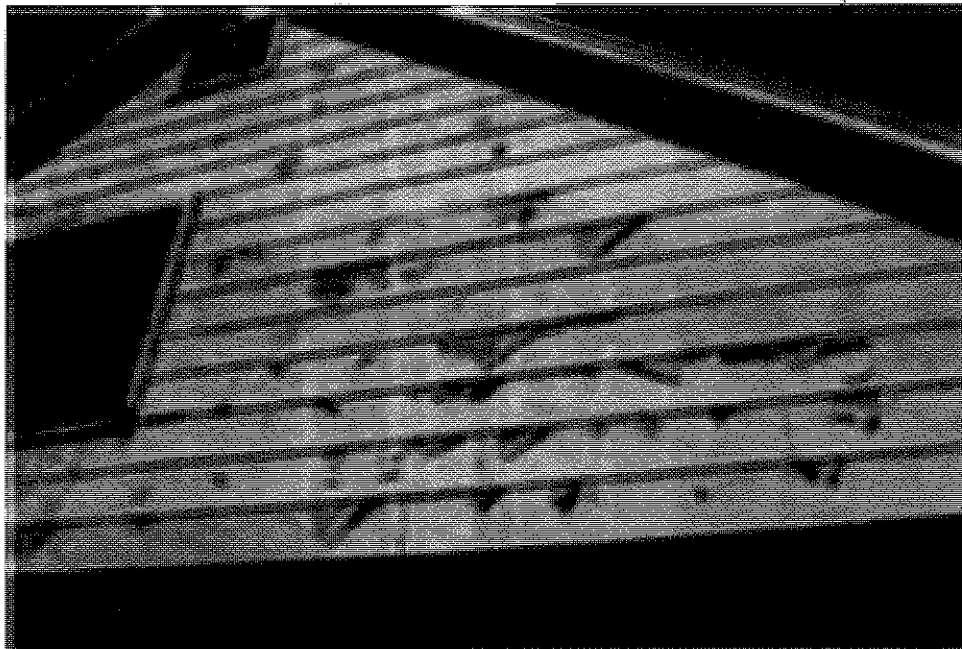
5. Peeled paint on the masonite-type siding.

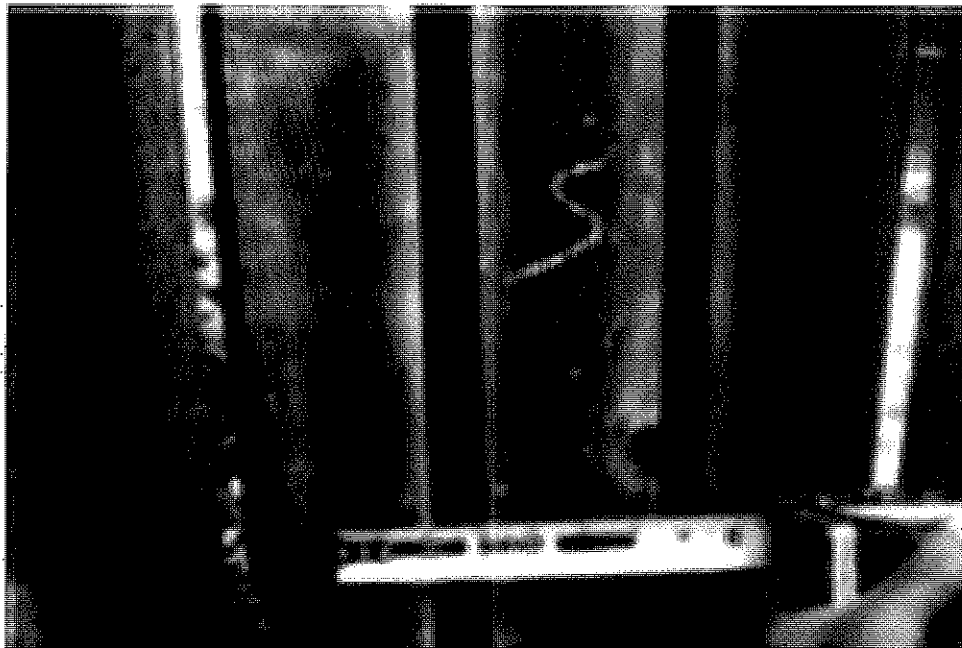
13. Wood privacy fencing facing south showed impact marks measuring up to 1/4 inch wide.

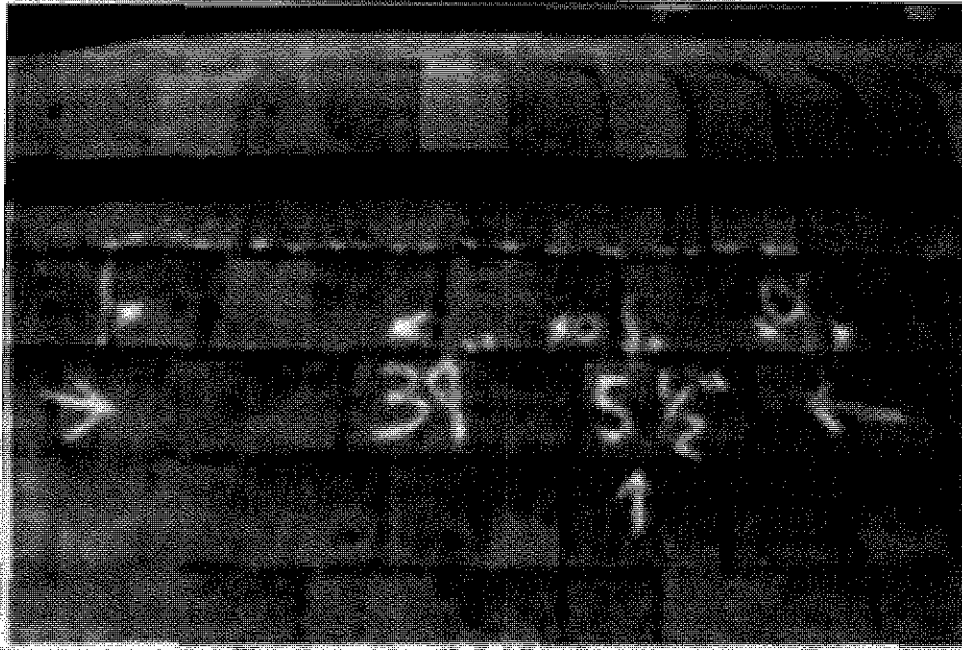
19. Shingles, damaged, on the south side of the garage, showing the number 39 and the fraction 5 1/2.

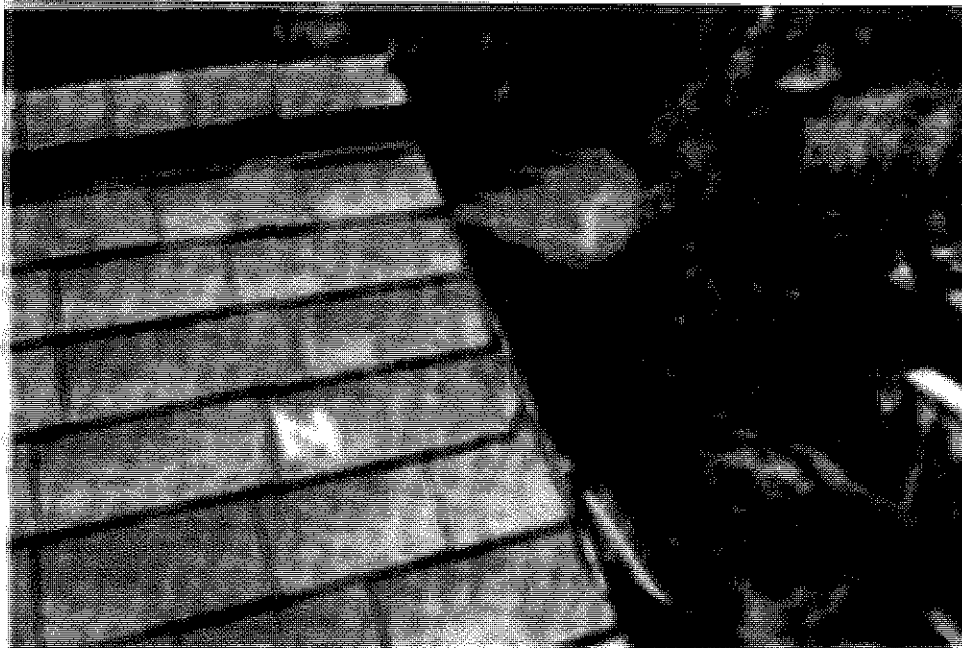
29. Tree abraded shingles on the garage north slope.

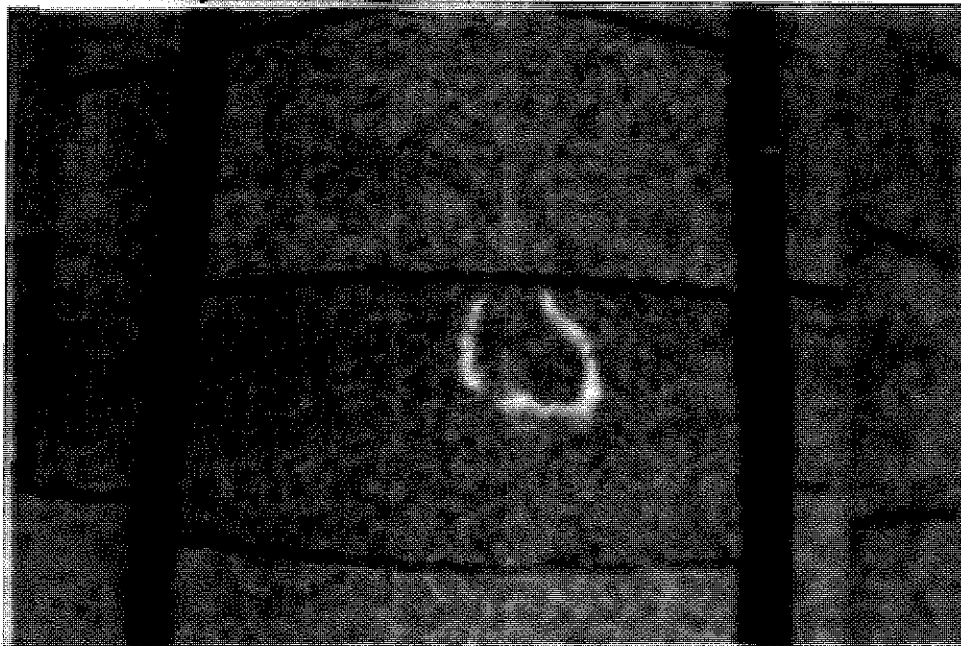
31. Ridge cap with granule loss and a soft spot.

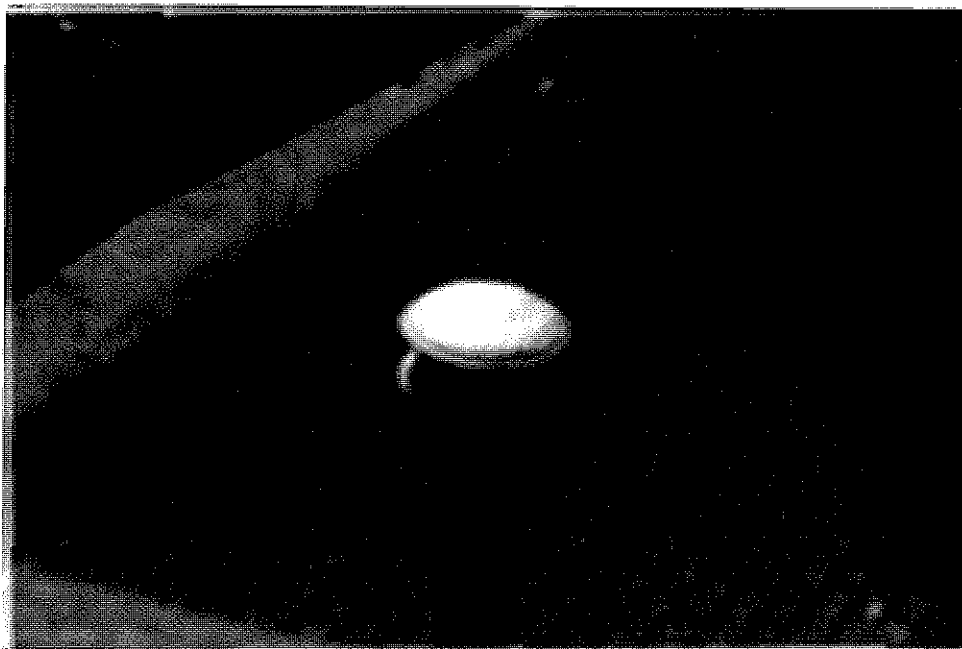
44. Dents in metal exhaust vent.

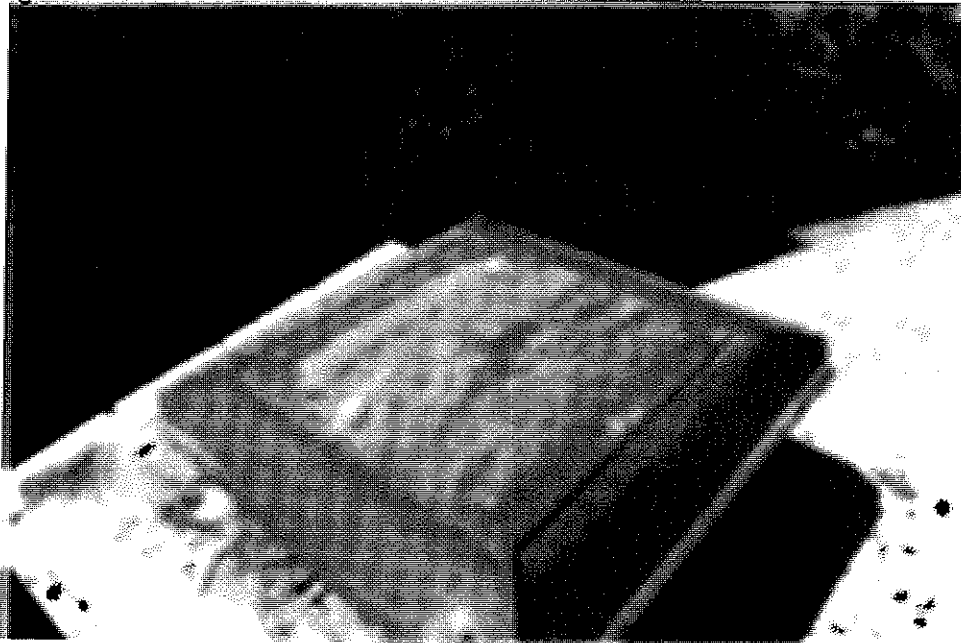
45. Chimney vent cap was not dented.

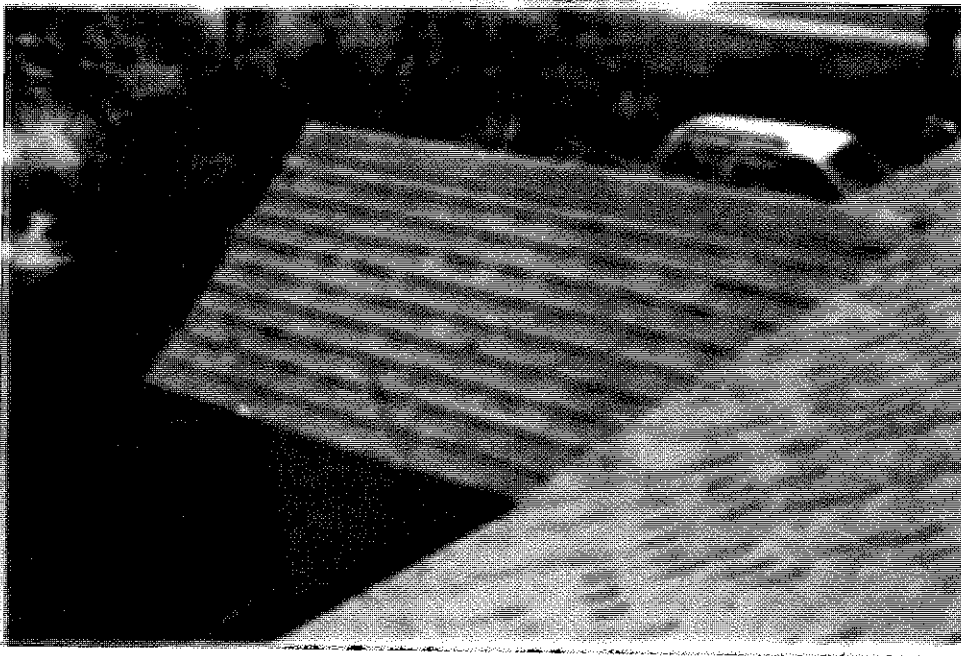
46. Tree abraded shingles on the front slope east dormer.

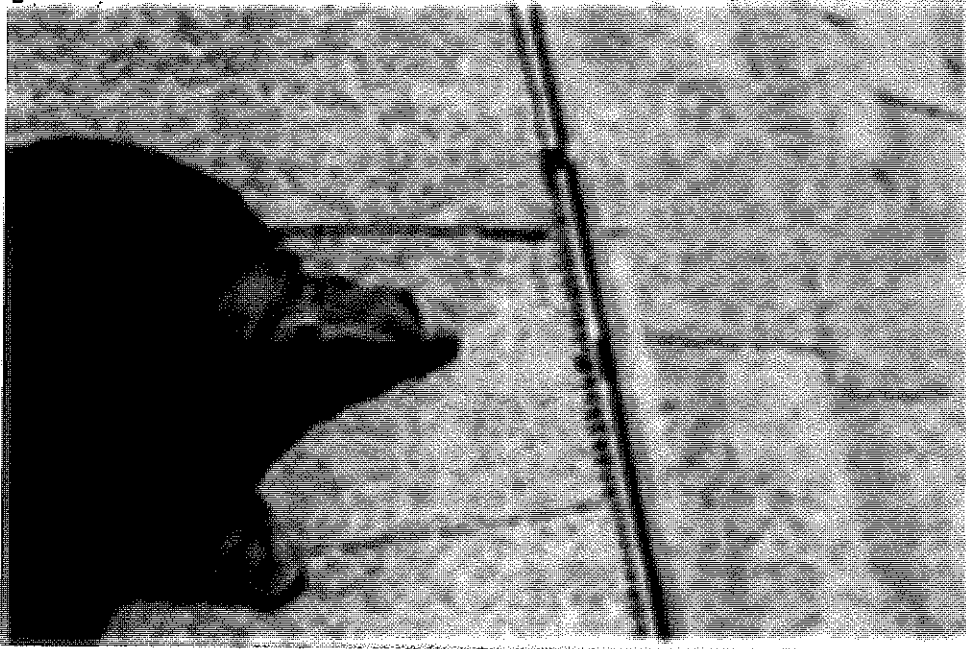
51. Surface anomaly in the ridge cap.

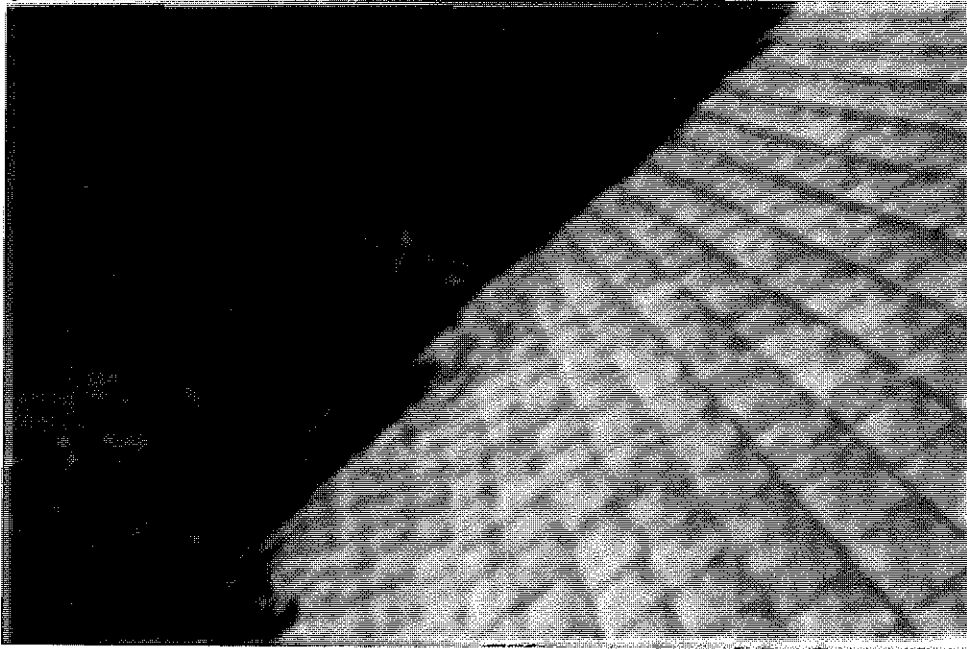
55. Another view of the tree abraded shingles on the rear slope west end.
